Water Compliance Inspection Report

**National Pollutant Discharge Elimination System
(NPDES)
Inspection Report**

**Independent Meat Co.
2027 Orchard Drive East
P.O. Box EE
Twin Falls, Idaho 83303**

NPDES Permit # ID0000388

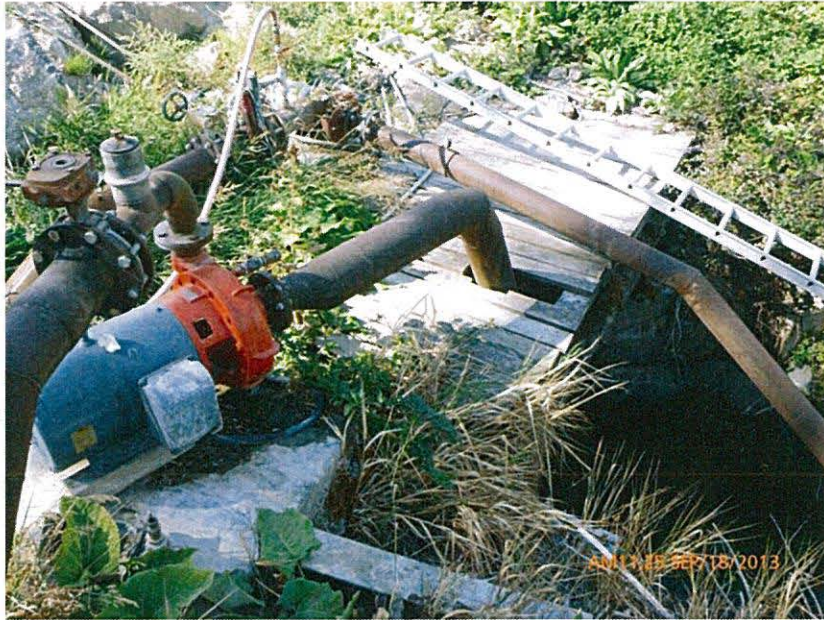
Photo No. 2 (P1000211)

A centrifugal pump draws water from the seep tunnel and pumps it across Rock Creek to the water-cooled condenser located at the rear of the IMC facility.

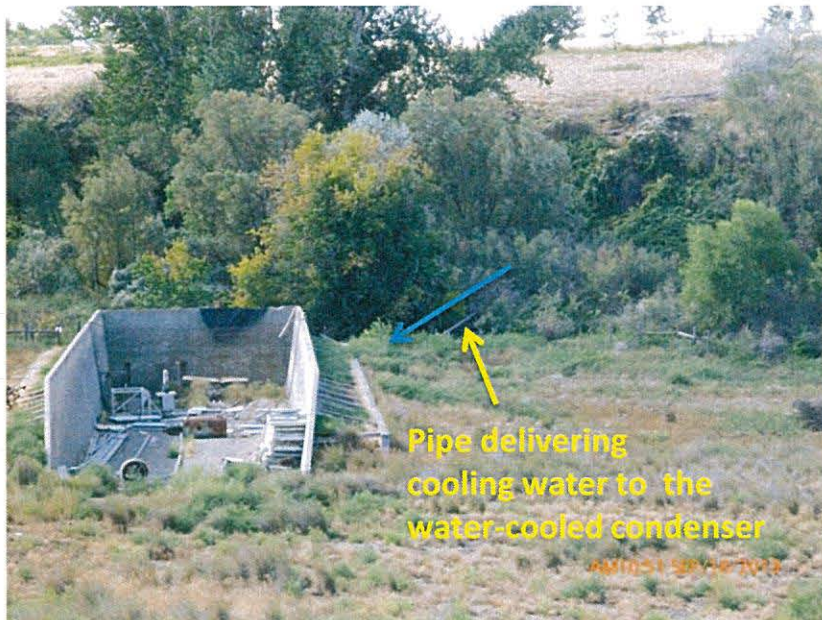
Photo No. 4 (P1000204)

Facing south from below and behind the IMC facility, the pipe conveying cooling water from the seep tunnel to the intake side of the water-cooled condenser can be observed where it spans Rock Creek.

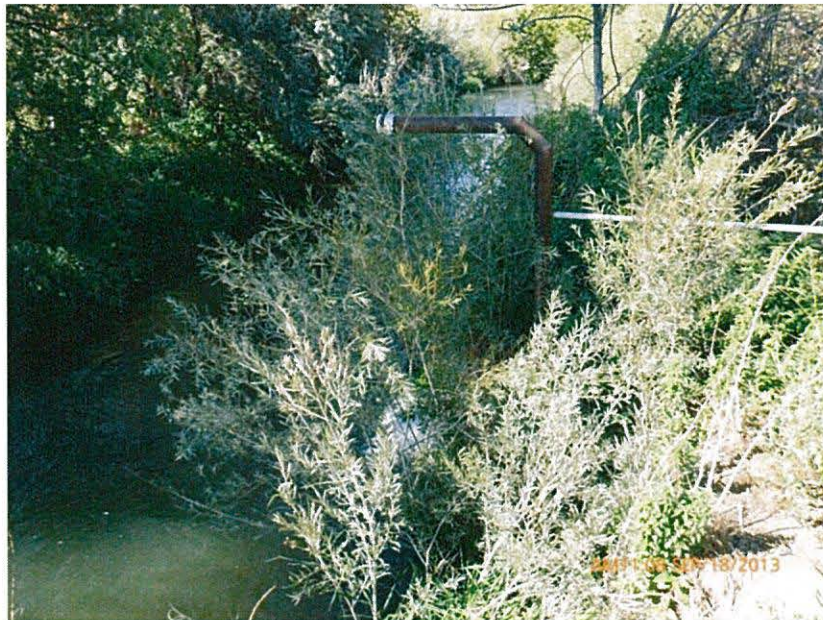
Photo No. 7 (P1000206)
The non-contact cooling water flowing from the water cooled condenser is discharged to Rock Creek at this location.
